# Application of Active Thermography for Detecting Material Defects in the Building Envelope

Henryk Nowak  
Monika Kucypera  
*Division of Building Physics and Computational Design Methods  
Institute of Building Engineering  
Wroclaw University of Technology  
Wroclaw, Poland*

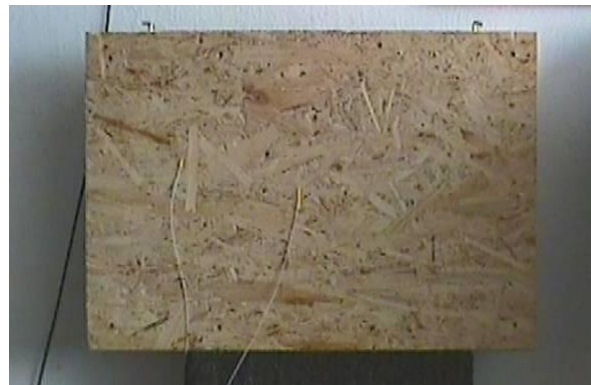
Figure 3. Diagram of wall models under test and photo of measuring stand.

For this test, we examined two models of multi-layer chipboard walls of identical heat capacity with inclusions added of two materials of very different thermal properties, i.e. steel ( $\lambda=58 \text{ W/mK}$ ) and foamed polystyrene ( $\lambda=0,04 \text{ W/mK}$ ). These plates were tested with active thermography in reflection mode. The goal of the test was to determine the size of the material inclusions and their thermal properties.

Figure 2 is a diagram of the experiment set-up for active thermography, while Figure 3 illustrated the placement of the inclusions in the material under testing and the view of the measuring stand.

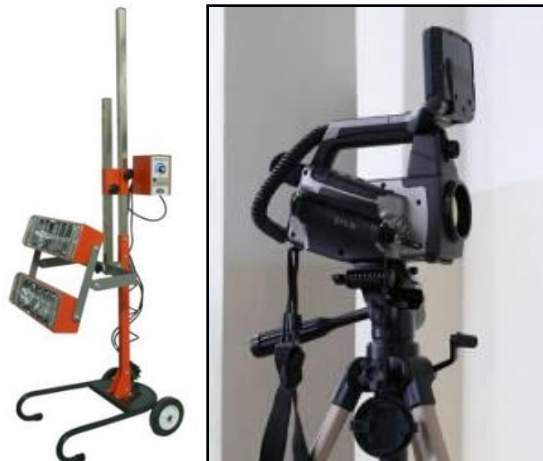
Figure 4. Equipment used in examinations: infrared radiators type FOBO EP 102 and FLIR ThermaCAM P65 thermal camera.

Two infrared radiators (type FOBO EP 102) with total power of 2 kW were used to heat the plate with inclusions. A thermal camera (ThermaCAM P65) was used to record sequences of thermal images of the surface as it cooled [Fig.4].

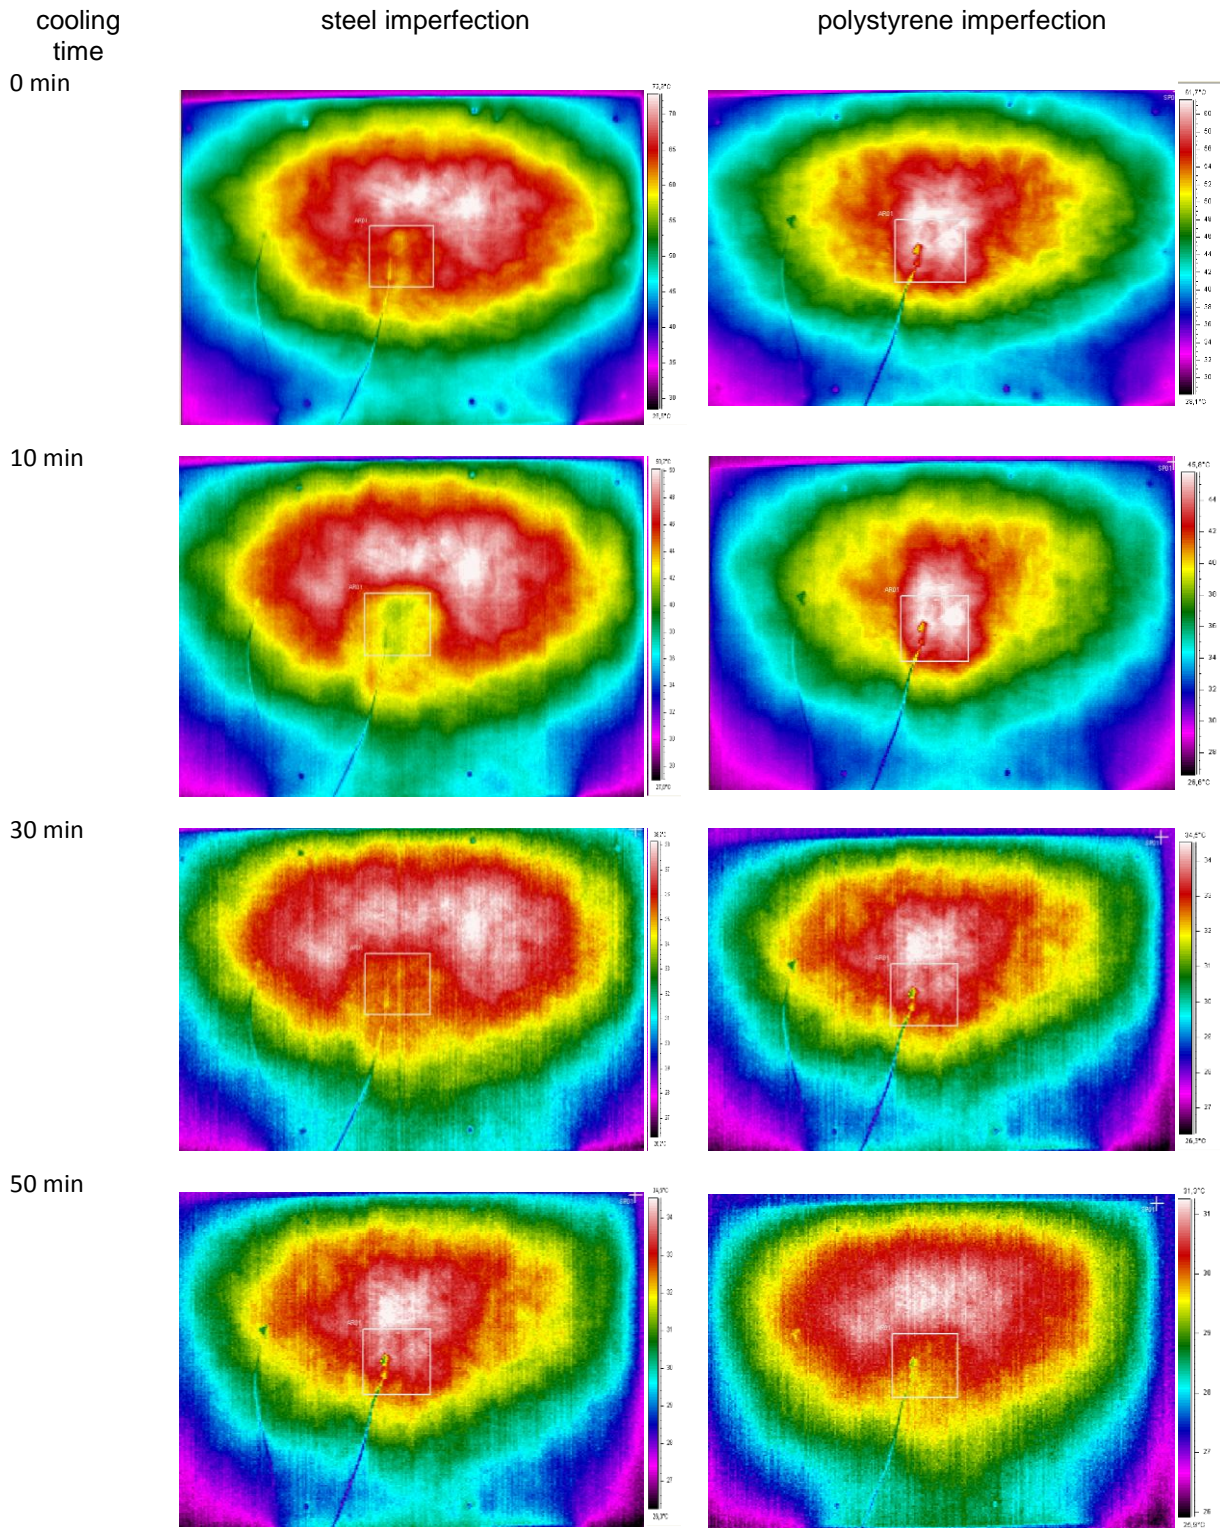
*Figure 5. Variability of temperature distribution in time from starting of cool down period for steel plate defect (left) and polystyrene defect (right).*

The sample under test was heated with an infrared radiator for 30 minutes. Then, using a thermal camera, the temperature distribution of the sample surface was recorded once a minute. The variability of temperature distribution over the area of the element under test is shown in Fig. 5.

Two chipboard wall models were heated up for 30 minutes by infrared radiator, and then, after switching it off, thermal images were recorded once a minute. During the first phase, i.e. for the first 10 minutes after disconnecting the lamps, the temperature distribution waveform for both plates – steel and foamed polystyrene inserts – were quite similar. No discontinuities were visible in temperature distribution on the plate surface in both cases. After 10 minutes, however, the temperature over the heterogeneous area on the plate with the steel insert was lower than for the remaining plate area while in the plate including the foamed polystyrene insert, the situation was reversed.

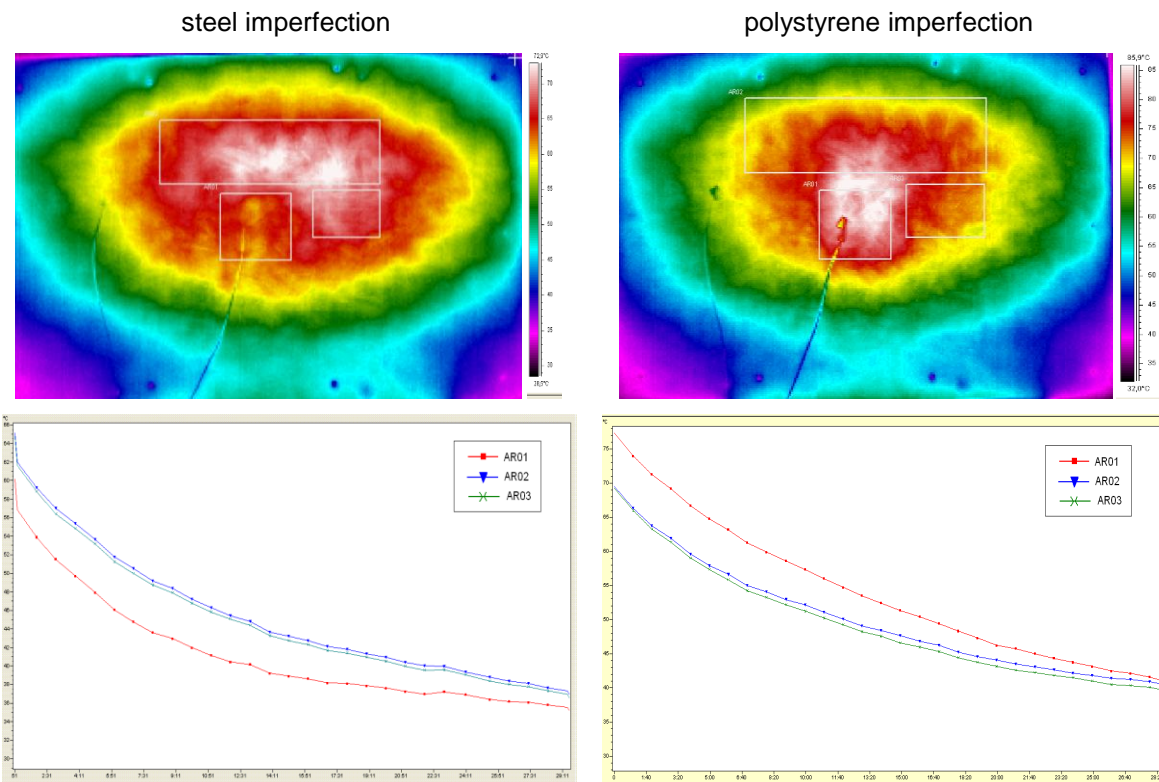
Figure 6. Variability over time of the average temperature of the area over homogenous material and average temperature of area over the material inclusions of steel and foamed polystyrene.

The deviation of temperature change over time points out the defect under the surface of the material under test. Based on temperature readings taken over a period of time on the surface of the sample as it cooled, an average temperature versus time was found for the area over the homogenous material and for the area with the discontinuity. Temperature versus time for homogenous material is shown in Figure 6 in blue and green (two selected areas), while the area over the defect is shown in red. It is clearly shown that a defect under the surface changes the temperature-time relationship. Depending on thermal capacity of the defect, the temperature-time waveform for the heterogeneous area is above or below that for the homogenous material. Namely, for a defect in which thermal capacity is higher than the material tested (e.g. steel), the waveform for heterogeneous material is below the waveform of the homogenous area, while in the case of material with a lower thermal capacity than the sample (foamed polystyrene), the situation is reversed, i.e. with the waveform above homogenous material.

The time-related temperature distribution waveform for homogenous material differs from that for the area above a defect. Depending on the type of defect, i.e. its thermal capacity, the deviation is above or below the temperature distribution waveform for the homogenous area [Fig.6].

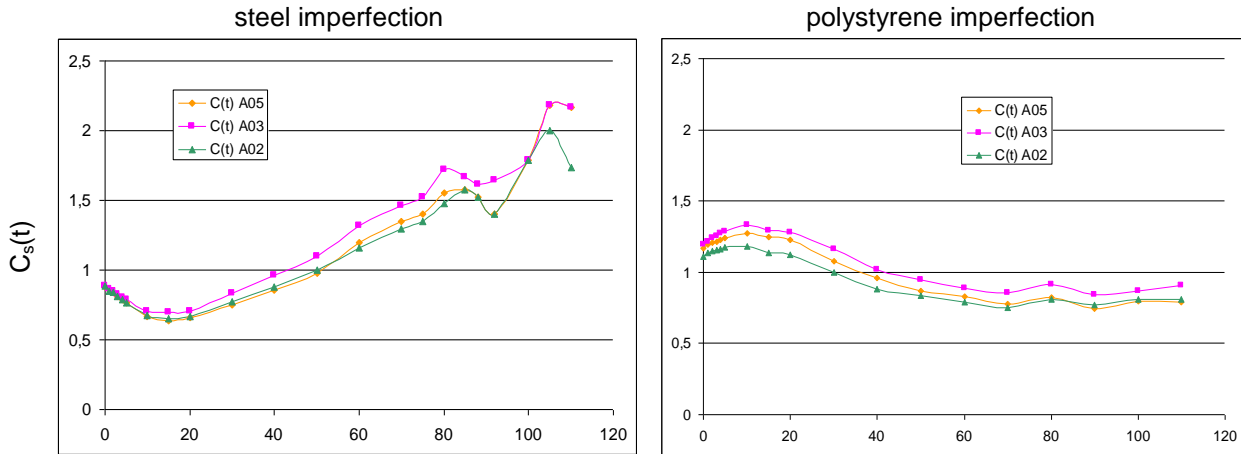
Figure 8. Diagram of standard contrast (equation 2) during cool down period for the sample tested at three measuring points, for defects of steel (left) and foamed polystyrene (right).

As shown in Figure 8, the standard contrast for the sample with the steel defect, independent of the selected point where it is calculated, reaches its extreme value after about 10 minutes and then rises significantly. The standard contrast for the sample with the foamed polystyrene defect also reaches its extreme value after about 10 minutes. Thereafter, however, it declines considerably until it stabilizes somewhere near a constant value of about 0.8. Hence, as can be seen, the tendency of this waveform formation depends on the type of subsurface defect material and its attendant thermal properties.

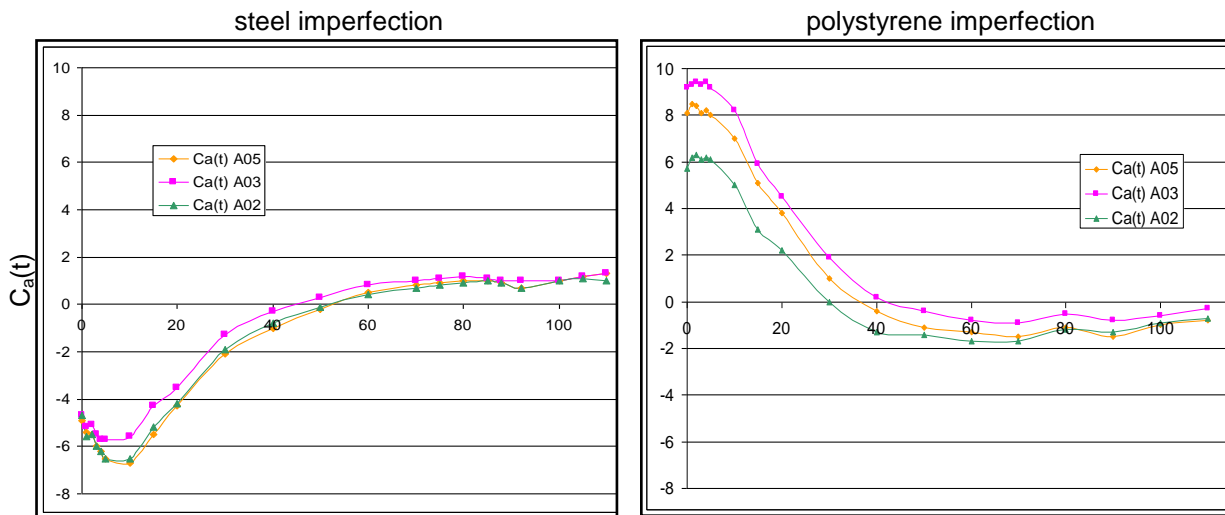
Figure 9. Time diagram of absolute contrast (equation 1) during the cool down period for the sample test at three measuring points, for defects of steel (left) and foamed polystyrene (right).

The absolute contrast for the sample with the steel defect reaches its extreme value after about 10 minutes and then rises significantly until it stabilizes at a constant value of about +1, as shown in Figure 9. The absolute contrast for the foamed polystyrene defect also reaches its extreme value in about 10 minutes, but, diminishes more and stabilizes at constant value about -1. Depending on thermal properties of the defect, the absolute contrast of the sample under test may have either positive or negative values.

The values of absolute contrast were significantly lower than zero in the surface material above discontinuities with higher thermal capacity than the sample itself (steel). In the case of a defect material with a thermal capacity lower than that of the sample (foamed polystyrene), the value of absolute contrast will be higher than zero.

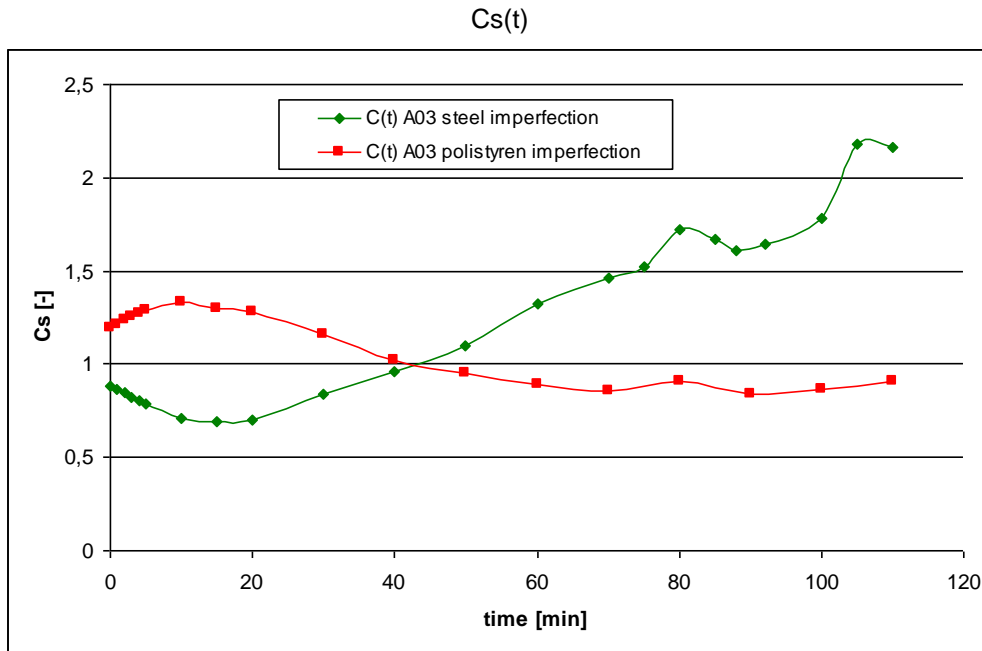
Figure. 10. Time diagram of standard contrast for defects of steel and foamed polystyrene at selected points for samples under test.

Figures 10 and 11 show that independent of the defect material, both standard contrast and absolute contrast reach their extreme value at the same time after the cool down phase begins. This may be an indication that the defects are at the same depth. However to confirm this theory, additional testing is necessary, which is planned in further research work.
